Test Report

Number	19-002077-PR01 (PB-A03-05-en-01)
Owner (Client)	ALUMIL S.A. Industrial Area 61100 Kilkis Greece
Product	Glass Railing
Designation	Shipping name: M8200
Details	Manufacturer ALUMIL S.A., - Kilkis; Material Laminated safety glass (LSG)
Special features	Deviations to the test method as shown in the detailed results, according to customers request.
Order	Resistance to wind load
Contents	The test report contains a total of 7 pages and annexes (7 pages).
Note	The test report shall only be published in its unabbreviated form. The "Guidance Sheet for the Use of ift Test Documents" applies.

Resistance to wind load

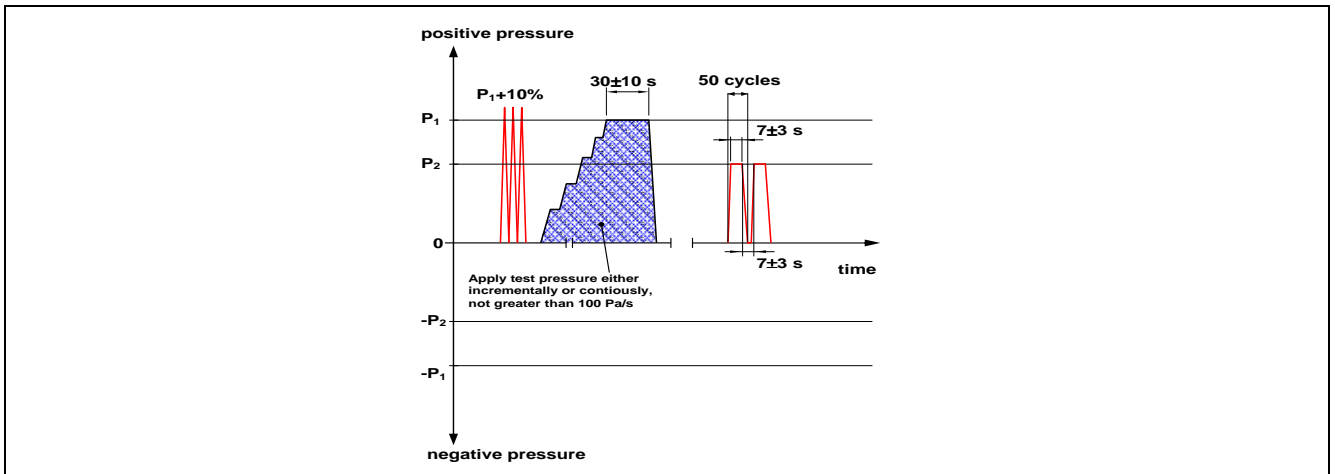
Illustration Test sequence for resistance to wind load - Deflection and alternating positive pressures

Resistance to wind load was tested in accordance with the standard and conducted in steps at positive pressure and negative pressure up to the test pressure p_1 . The test specimen was exposed to three pressure pulses $\Delta p_1 + 10\%$. This was followed by determination of the frontal deflection of test specimen for each pressure step when exposed to positive test pressure Δp_1 . Then the test specimen was subjected to 50 cycles at positive pressures of $+ \Delta p_2 = \Delta p_1 - 50\%$.

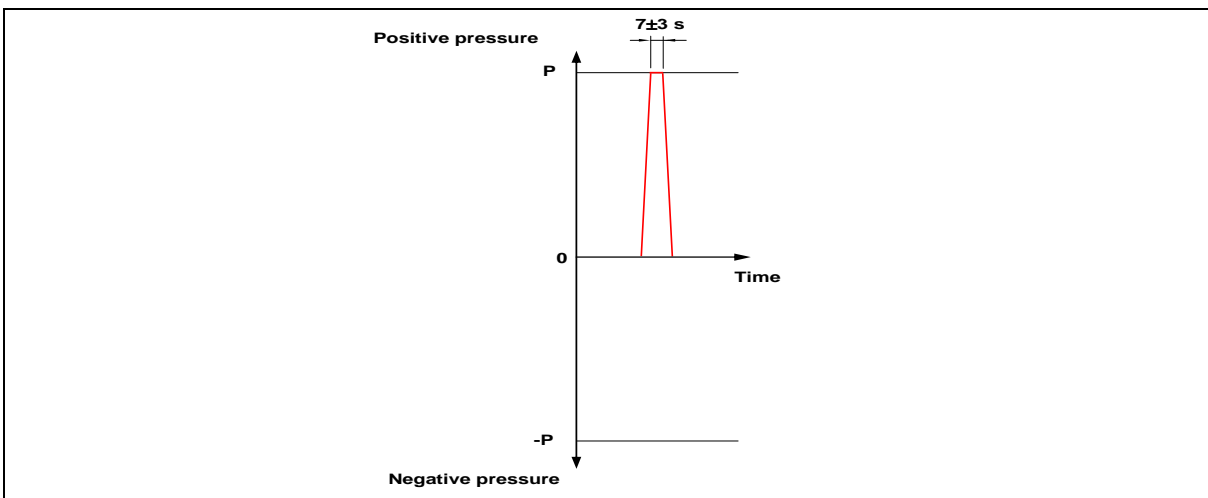
Illustration Test sequence for resistance to wind load - safety test

The wind resistance test (safety test) was conducted at positive pressure in accordance with EN 12211 up to test pressure $\Delta p = +4000$ Pa.

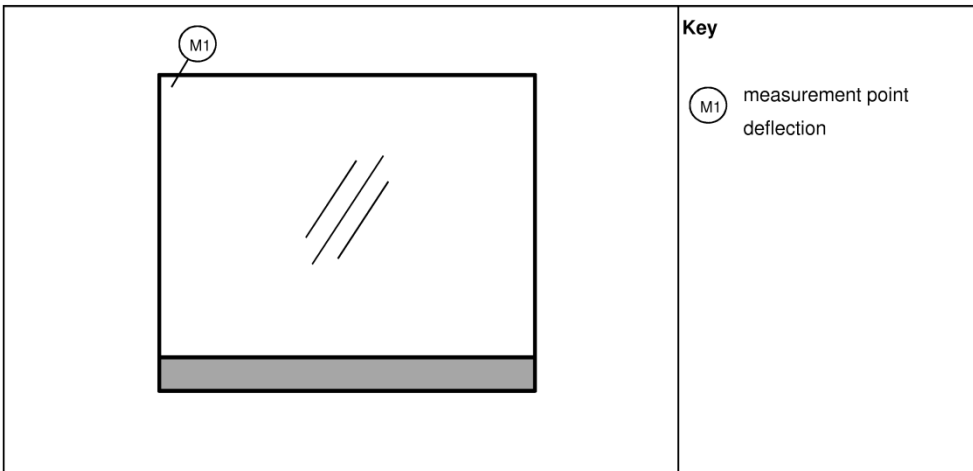
Measurement data/Results

Maximum test pressure: ± 3000 Pa 3 pressure pulses of 3300 Pa

Measured results of frontal deflection in mm		Positive wind pressure	Negative wind pressure
	Pa		3000
M1 in mm		181.0	-/-

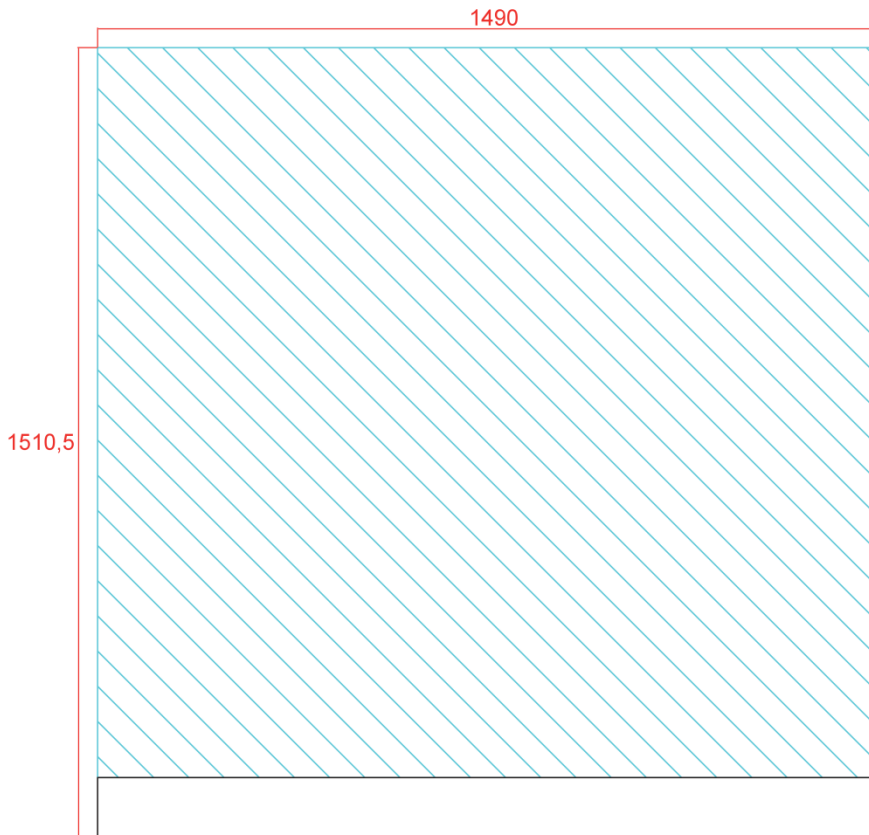
Picture 1 View

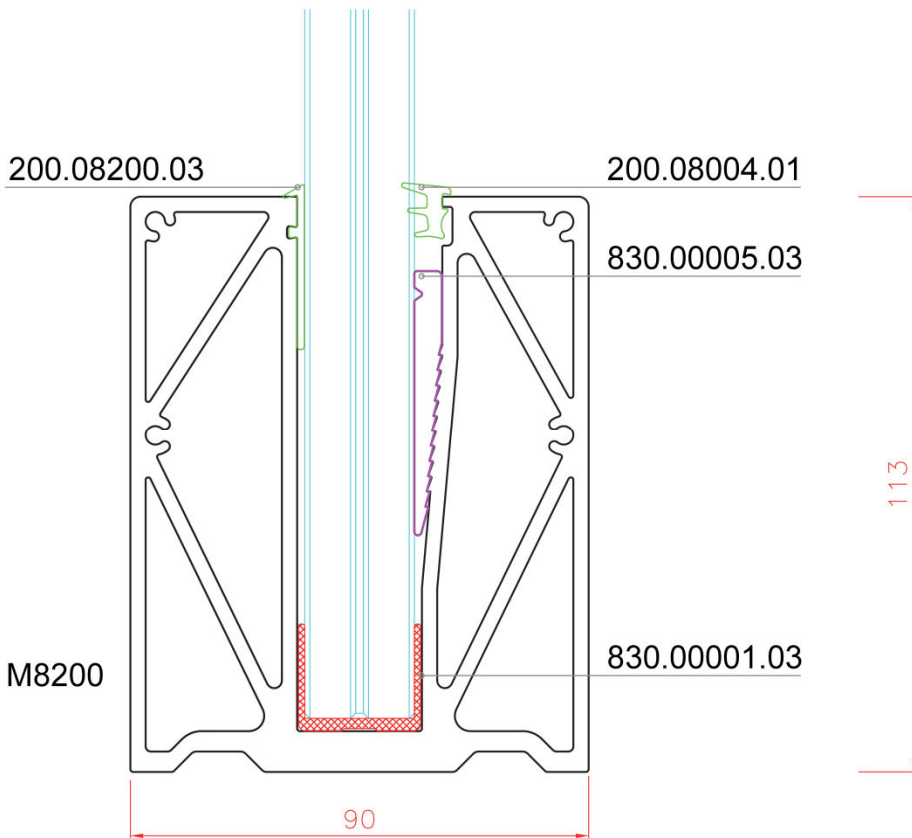
Picture 2 Vertical section

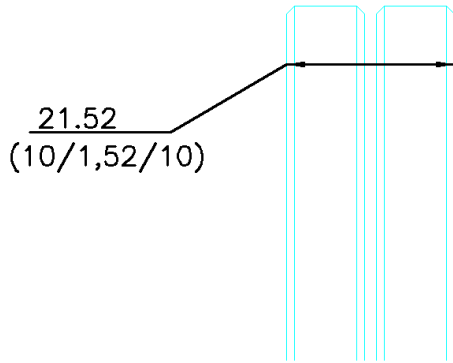
Picture 3 Glazing configuration

Eigenschaft Characteristic	Angaben des Auftraggebers (unverändert) Information provided by client (unchanged)
Lieferbezeichnung / Typ / Art.-Nr. Designation / type / item no.	Laminated safety glass
Abmessung (B x H) Dimensions (W x H)	1,490 mm x 1,500 mm
Gesamtdicke Thickness	21.52 mm
Aufbau Configuration	10 mm / 4 PVB / 10 mm
Glaseinstand Edge cover	105 mm
Folie (VSG) Film (LSG)	
Hersteller Manufacturer	Kuraray, Trosifol
Material Material	PVB
Gesamtdicke Total thickness	1.52 mm
Aufbau Configuration	4PVB
Verglasungsdichtung außen External glazing gasket	
Hersteller Manufacturer	Alumil S.A.
Lieferbezeichnung / Typ / Art.-Nr. Designation / type / item no.	200.08200.03
Material Material	EPDM
Verglasungsdichtung innen Internal glazing gasket	
Hersteller Manufacturer	Alumil S.A.
Lieferbezeichnung / Typ / Art.-Nr. Designation / type / item no.	200.08004.01
Material Material	EPDM
Anschluss an die Tragkonstruktion Fixing to the support structure	Bolted to surrounding frame

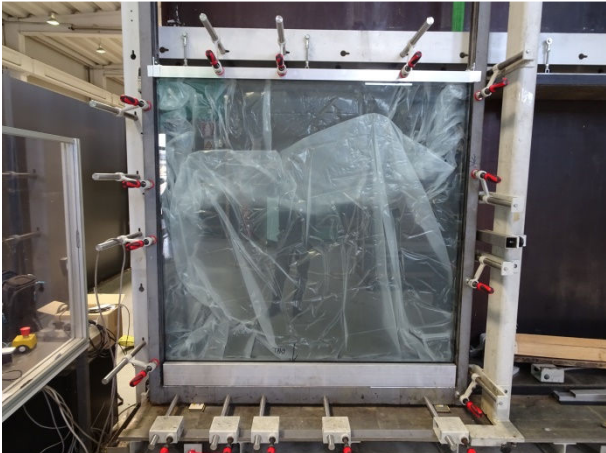
Picture 1 View of test specimen, internal view

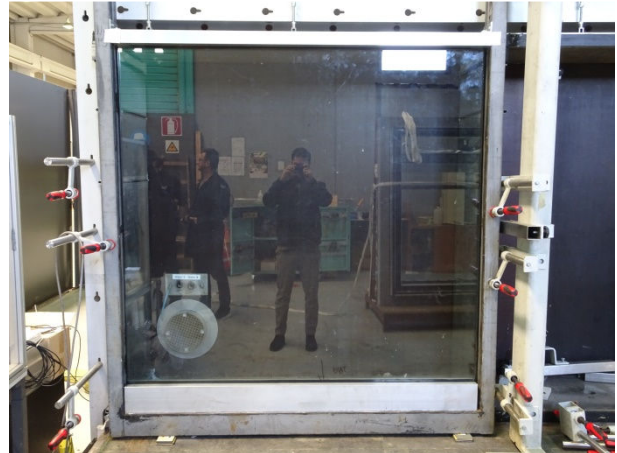
Picture 2 View of test specimen, external view

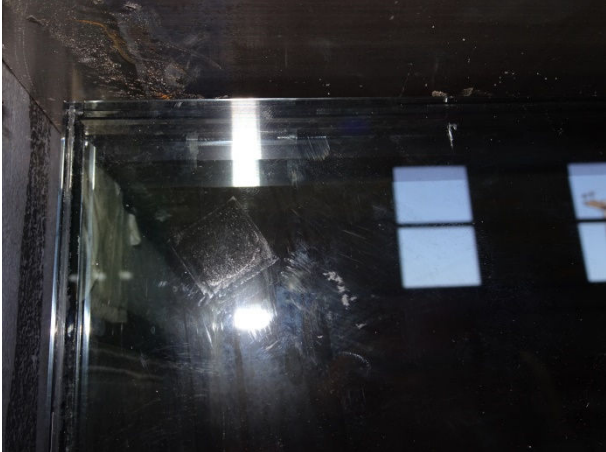
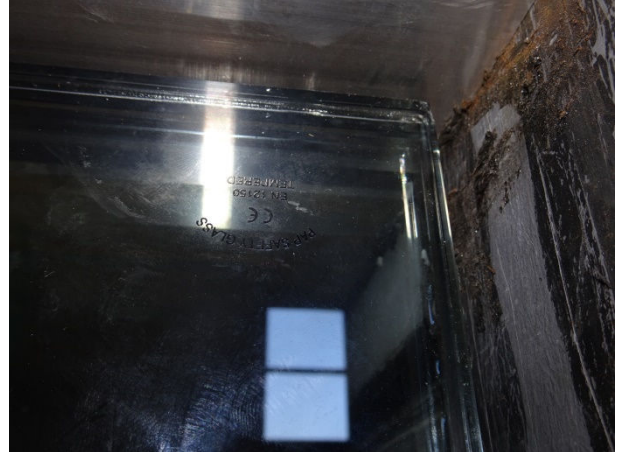
Picture 3 Corner of test specimen, at top

Picture 4 Corner of test specimen, at top

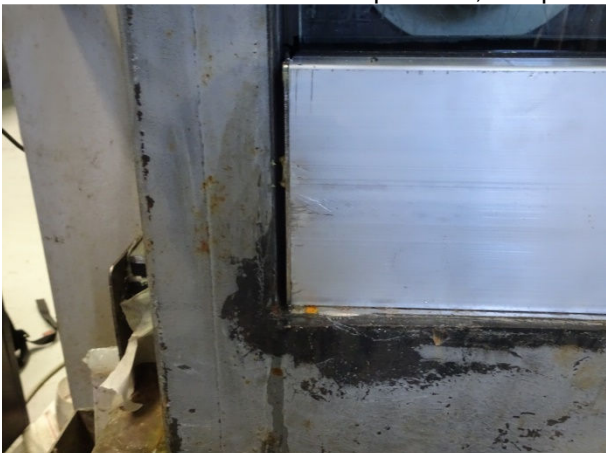
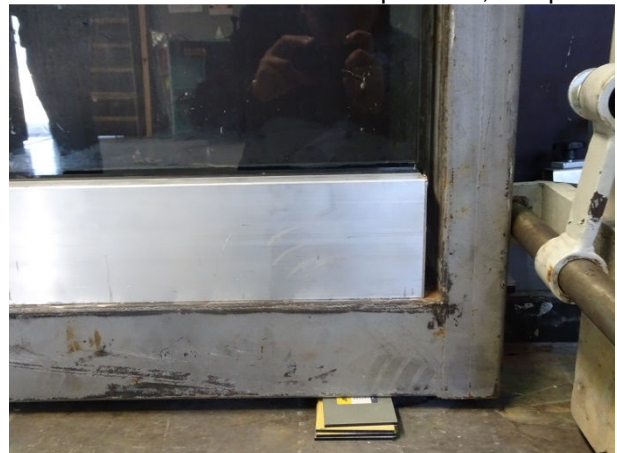
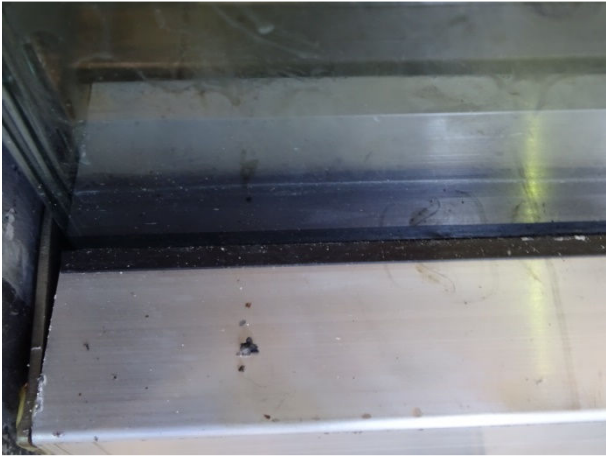
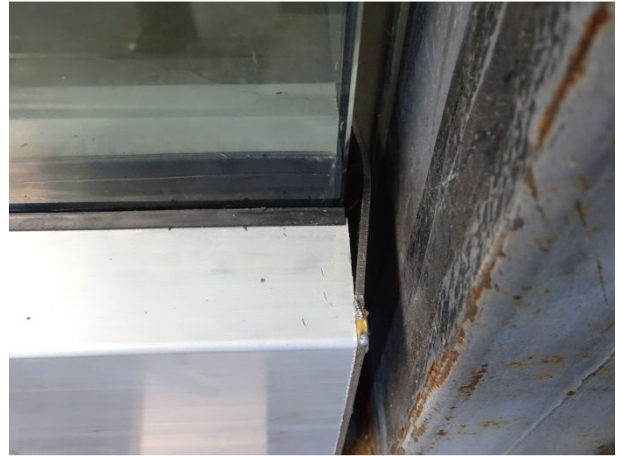
Picture 5 Corner of test specimen, at bottom

Picture 6 Corner of test specimen, at bottom

Picture 7 Corner of test specimen, at bottom

Picture 8 Corner of test specimen, at bottom

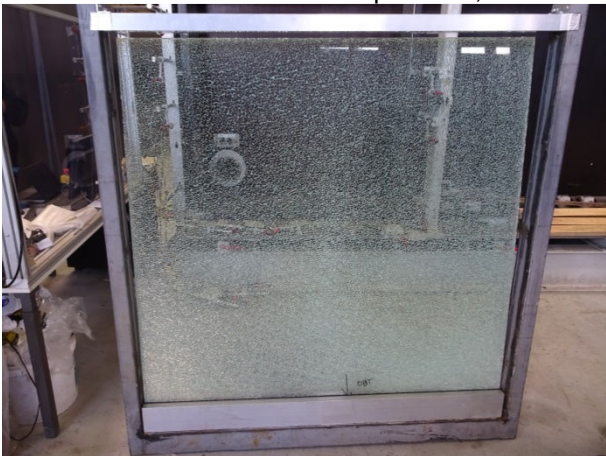
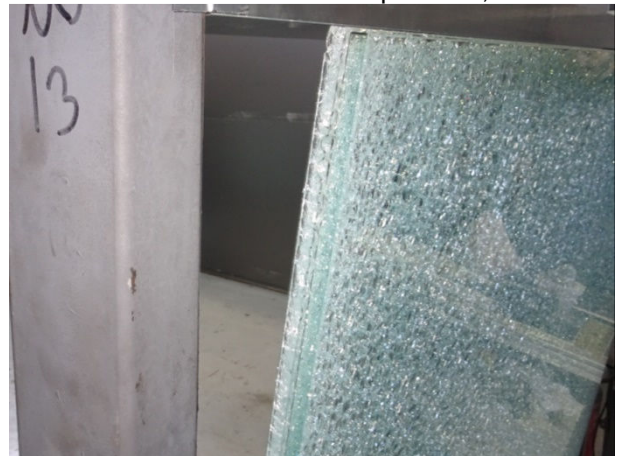
Picture 9 Fracture of the outer glass sheet at +4400 Pa

Picture 10 Fracture of the outer glass sheet at +4400 Pa

Upon customer request, the pressure was further increased to + 4500 Pa after passing the + 4000 Pa.
 Fracture of the outer glass pane at + 4400 Pa.
